LAKE QUINN DAM

NDI ID NO. PA-00145

PHASE I INSPECTION REPORT NATIONAL DAM INSPECTION PROGRAM

(11) February 1981

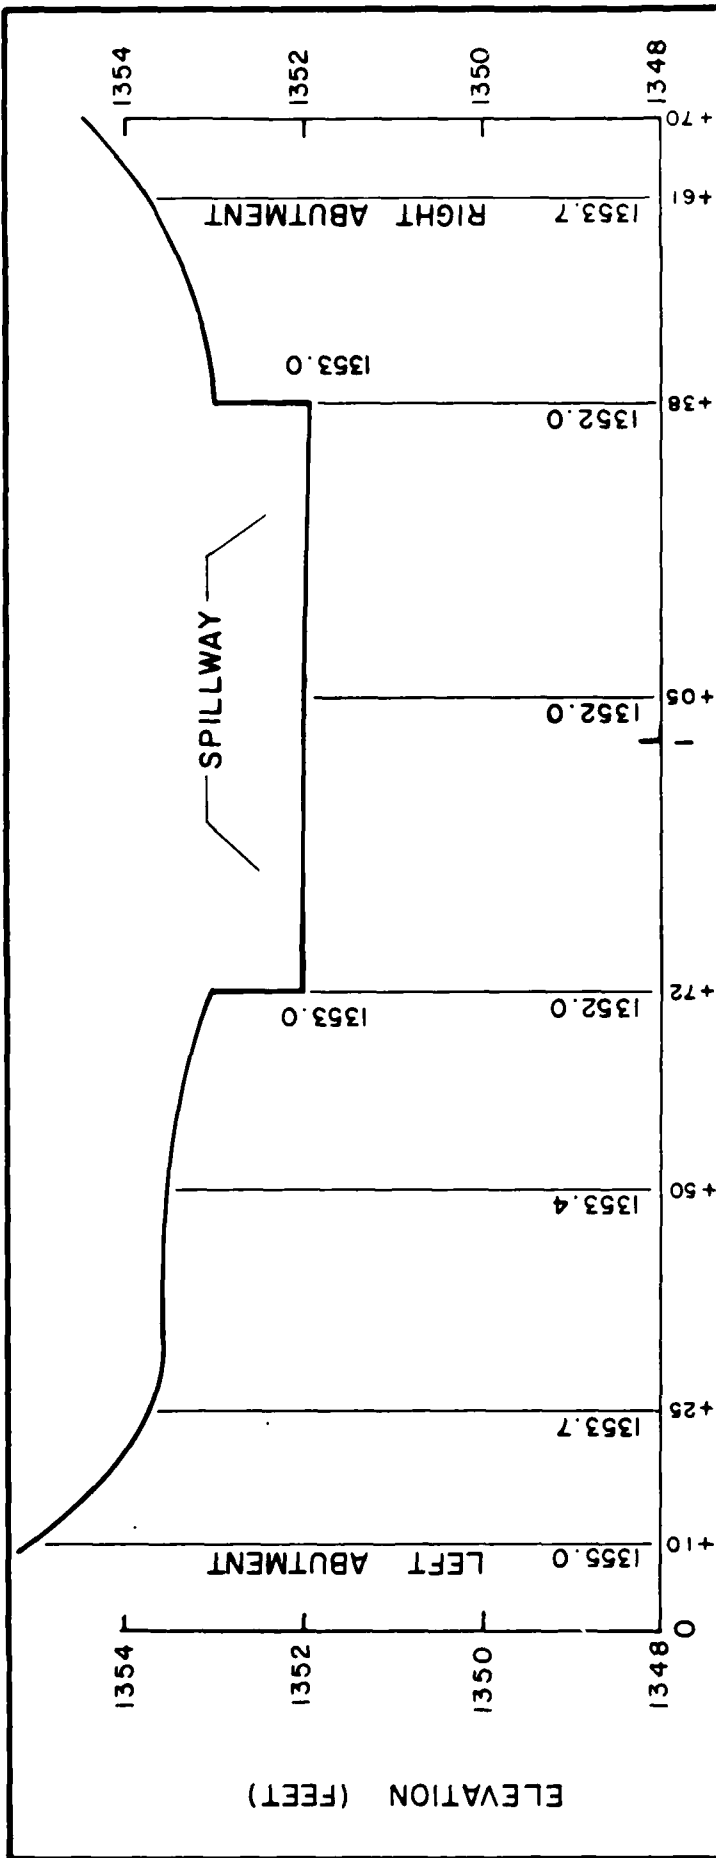
EXHIBIT A-1

FIELD SKETCH

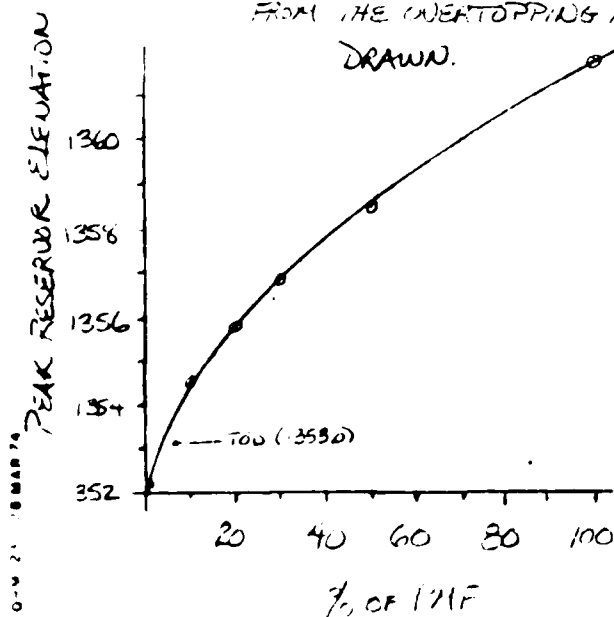
RESULTS OF THE OVERTOPPING ANALYSIS

LOW POINT OF DAM IS 1353.0

POINTS PLOTTED FROM PAGE 21/21 OF THE OVERTOPPING ANALYSIS OF THIS APPENDIX.

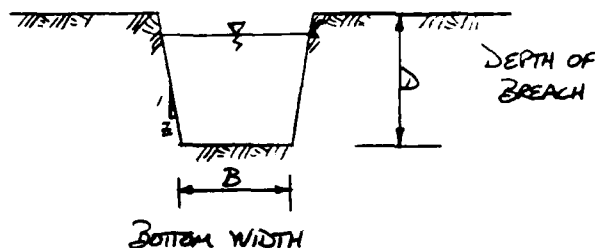
TYPICAL BREACH SECTION

PAST HISTORICAL EVENTS HAVE BEEN KNOWN TO OVERTOP THE EMBANKMENT BY AS MUCH AS 2.5 FEET. THIS OCCURED DURING THE OCT. 1955 & JUNE 1972 EVENTS. SINCE THE EMBANKMENT IS CONCRETE CAPPED AND HAS A RUBLE STONE DOWNSTREAM FACE, IT WAS FELT THAT A $1\frac{1}{2}$ FOOT OF OVERTOPPING FOR A SHORT DURATION COULD BE WITHSTOOD. THEREFORE, FOR THE BREACHING ANALYSIS, 10% OF THE PMF WOULD BE APPROPRIATE FOR THIS ANALYSIS.
